**Washington State Ferry Terminal
Structural Inspection**
By the Bridge Preservation Office

Kingston Ferry Terminal

Location	Bridge No.	Type	Inspection Date	Report Received
Slip 1	104/12FT	Routine & FC	9/10/2019	11/18/2019

BRIDGE INSPECTION REPORT

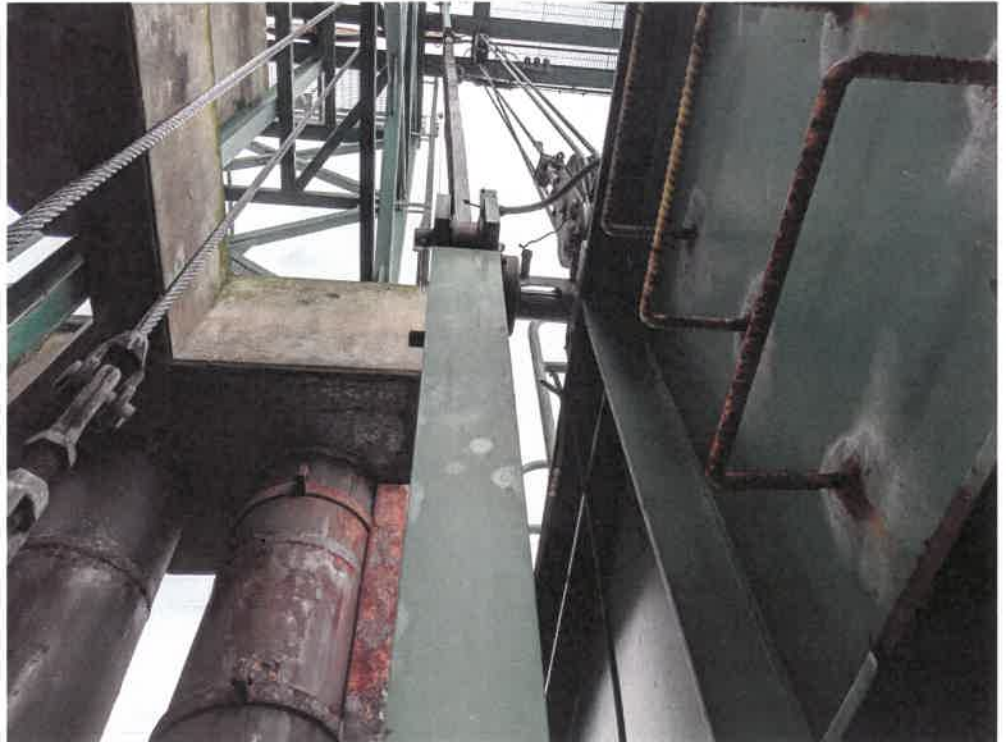
Two bottom tension link pins in the right end of the lift beam. Looking down.

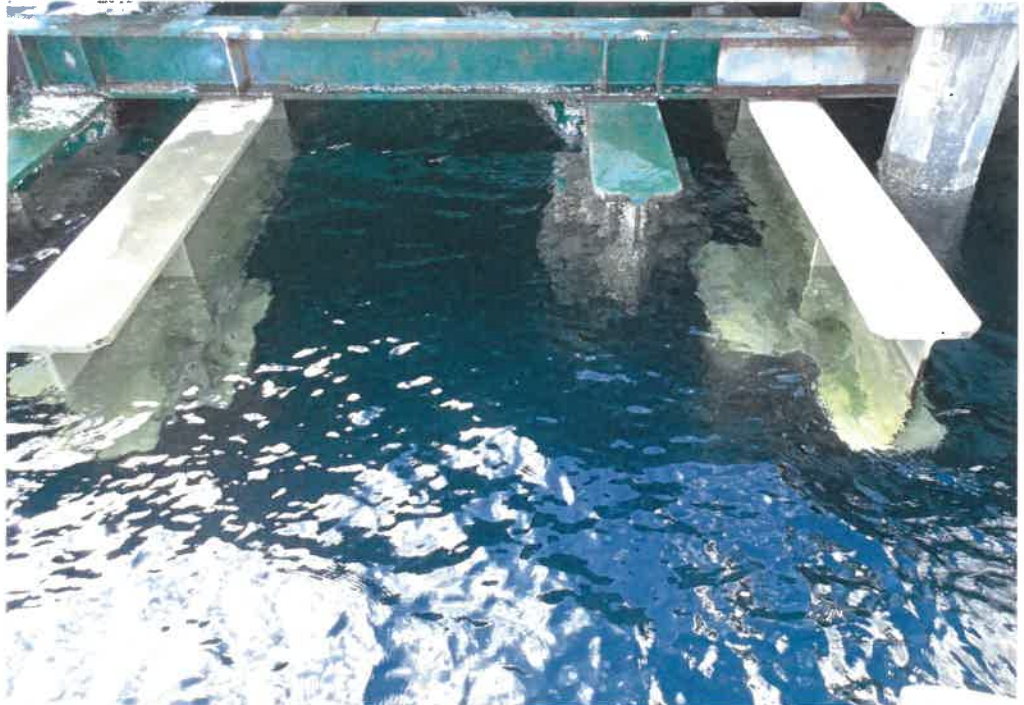
UW-5

The bridge seat now has a total of 8 steel piles in the bridge seat retrofit support frame. The frame has four 24" x 3/4" steel piles and has been enhanced to accommodate four new 30" x 3/4" steel piles added in 2017 (Photos UW-3 and UW-4). The new piles are rusty with no coating. Random thickness readings were taken and no section loss was noted (Photo UW-5).

Random thickness readings of the steel piles were taken. Bridge seat Pile 1AL is shown looking down.

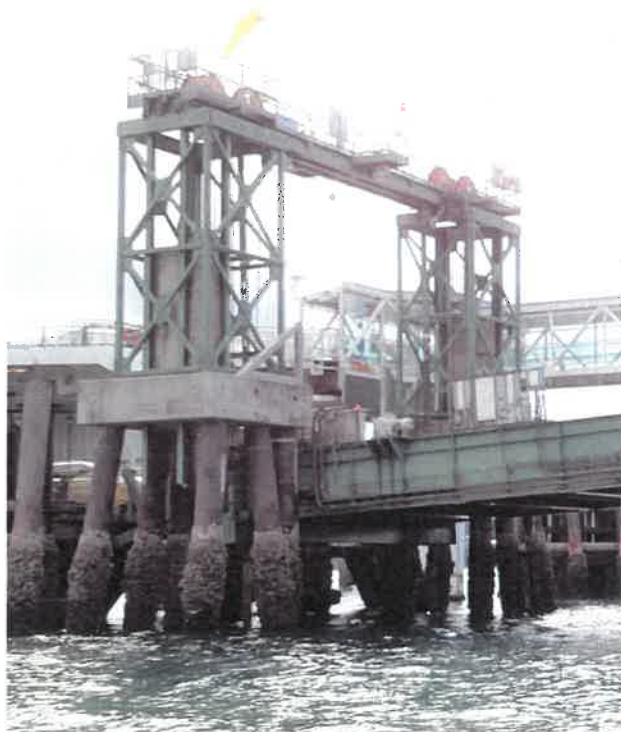
15 to 20 ft. deep area of scour from ferry prop wash between the towers and the bridge seat (estimated based on diver depth gage).

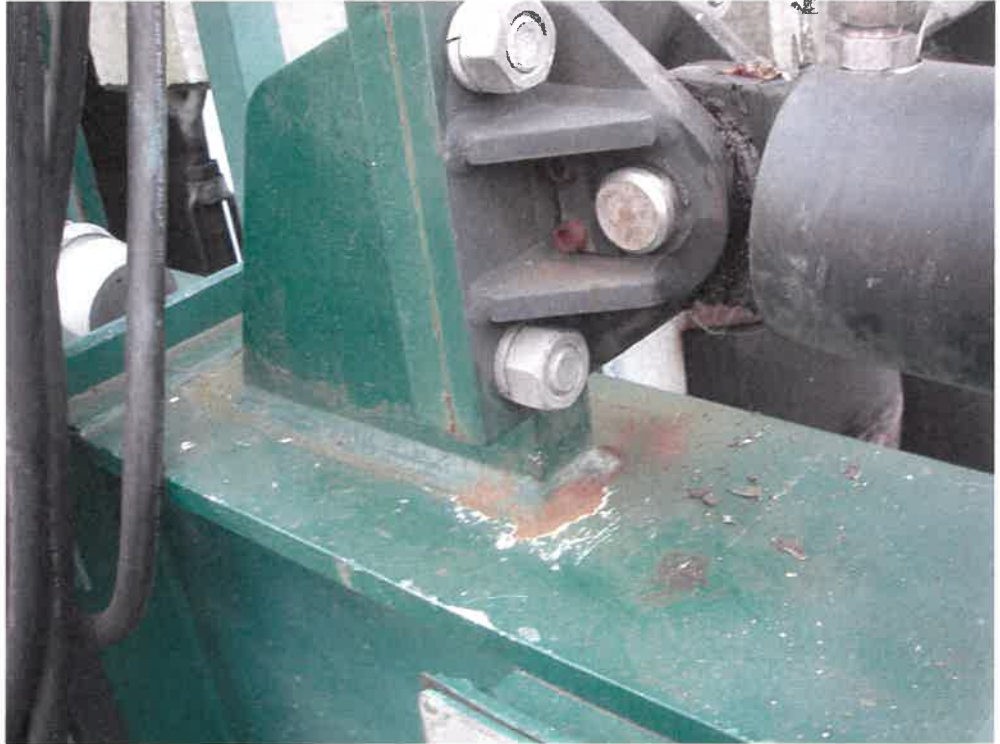
SI-120

Girder bottom flanges have rust blooms, with laminar rust and section loss concentrated near the seaward ends. REPAIR #10018.

Right Girder bottom flange at seaward side of liftbeam, showing section loss to flange and general rust at connection.

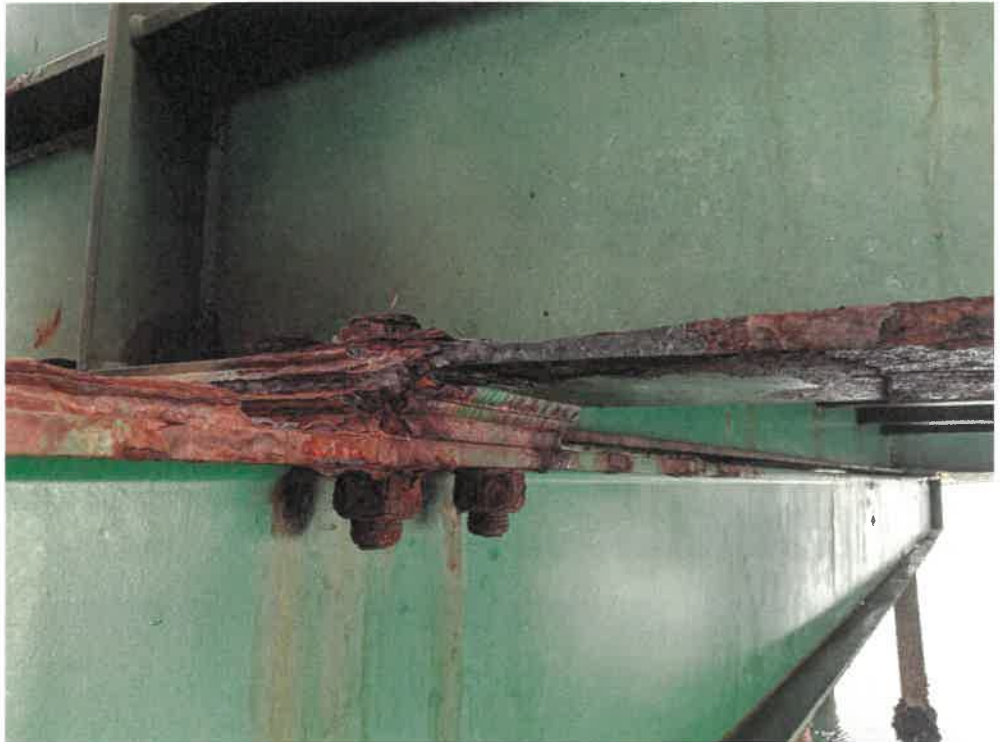
Floorbeam 6, left side shown, typical paint failure and corrosion.

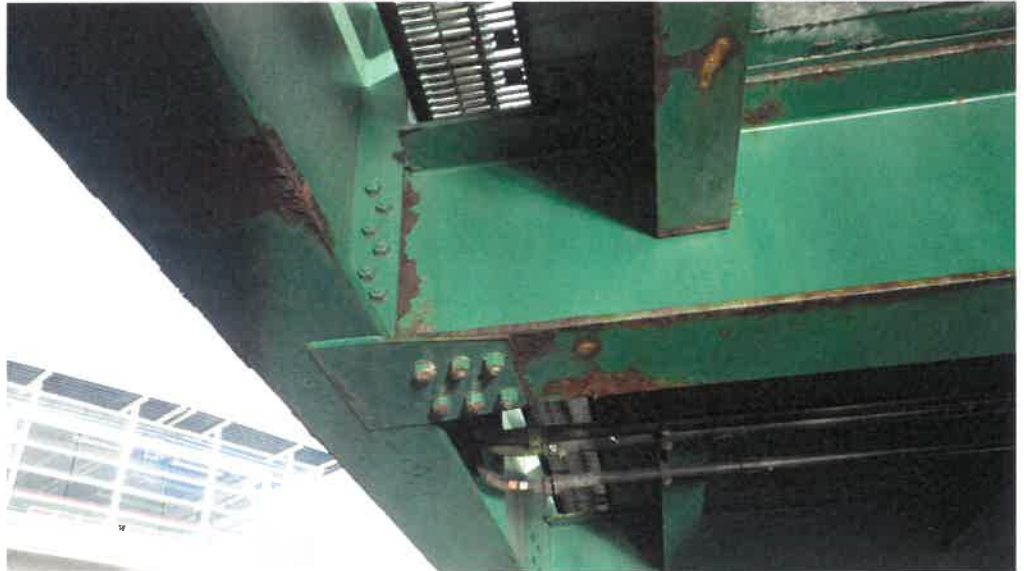
SI-114

Floorbeam 0, right side end connection replacement bolt is not painted and is a 3/4" diameter instead of the typical 7/8" diameter (Photo #114). REPAIR #10000.

Replaced bolt in FB to right girder connection unpainted. Bolt looks undersized; 3/4" vs. 7/8".

Repair No	Pr	R	Repair Descriptions	BMS	Noted	Maint	Verified
10000	2	B	Replace the rusty 3/4" diameter A325 bolt with a 7/8" diameter A325 bolt and paint the new bolt. (Right side of the bridge seat floorbeam to girder connection)	8206	9/2/2008		
10018	1	B	Paint on the bottom flange of open girders, gussets, liftbeam, liftbeam bolts, stingers, floorbeams, apron hinge pins, and apron lift connections to girder top flange have numerous rust blooms. See referenced photos for typical and specific locations. At locations of rust blooms clean to bright steel, prime, and paint. 2019 - CRT/MDM - Added locations to repair and updated/added photos.	1, 8130, 8201, 8206, 8209, 8301, 8305, 8341, 8901	9/14/2015		
10019	2	B	Relocate right outer dolphin (RO) sinker block and ladder away from Piles 2A and 3A that are being damaged.	8462	10/11/2017		
10020	1	B	Repair or replace the timber floating dolphin steel pontoons with gaping holes.	8463	10/11/2017

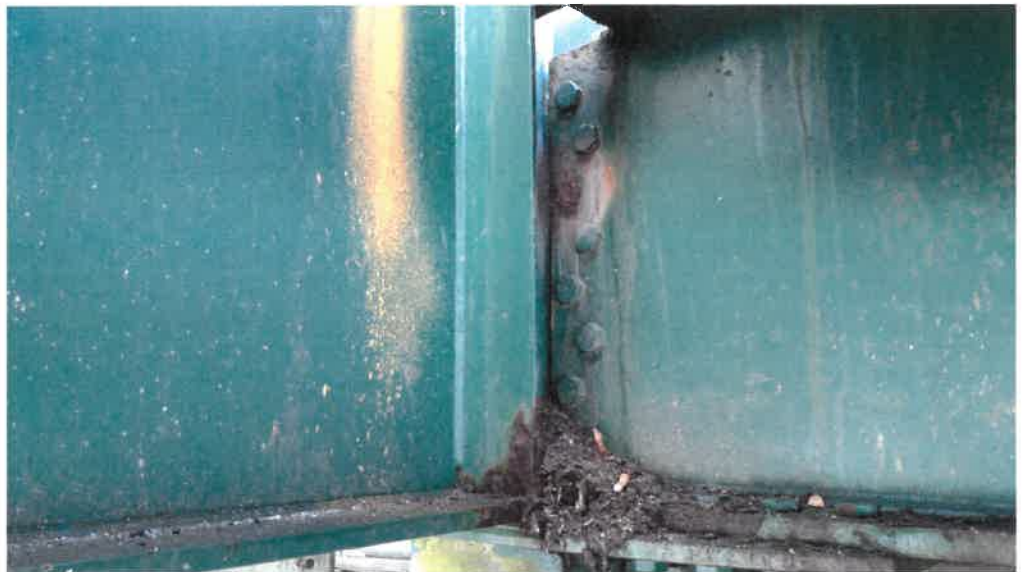
Floorbeam 9 stringer support/floorbeam stiffening plates have heavy laminar rust under the stringers with section loss to 1/4" remaining of 7/16" original thickness (Photo #119) REPAIR #10018 and #10023.

Floorbeam 9 section loss to stringer support stiffening plate.

Repair No	Pr	R	Repair Descriptions	BMS	Noted	Maint	Verified
10023	1	B	Floorbeam 9 stringer support/floorbeam stiffening plates have section loss under the stringer, with 1/4" remaining of 7/16" original thickness. Evaluate need to reinforce these plates based on current section loss.	8206	9/10/2019

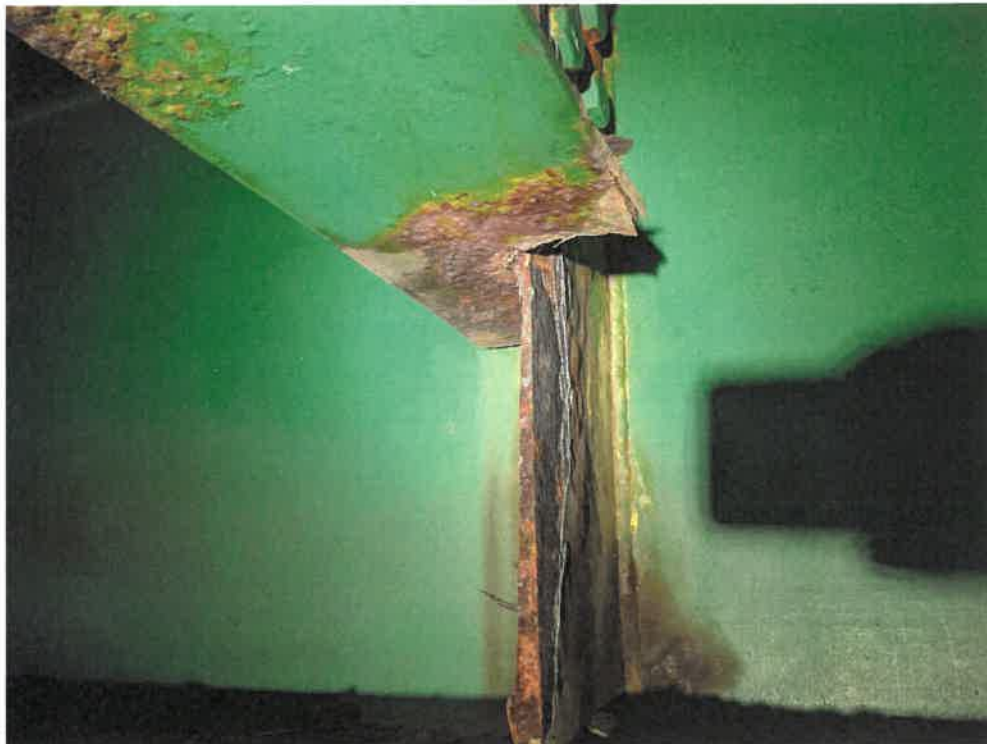
SI-109

The stringer connections at floorbeams are rusty at scattered locations, with higher rust concentrations at FB0 and FB9 (Element 8206 Photo #119 and Photo #109). REPAIR #10018.

The stringer connections at FB 0 are rusty.

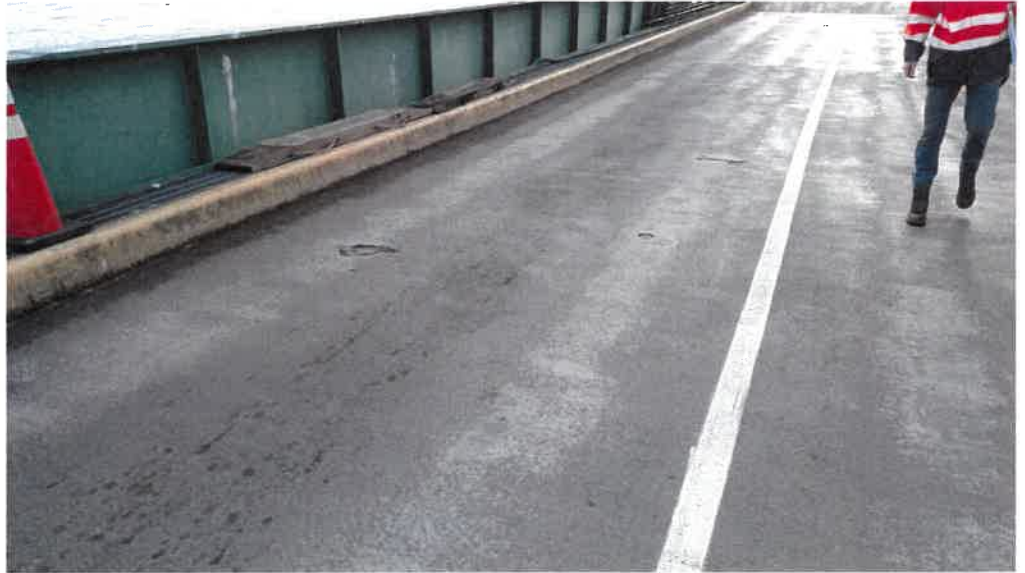
SI-125

Apron surfacing has scrapes and gouges, with several narrow patches and missing spots at the hinge (Photo #125).

Wear to non skid surfacing on apron.

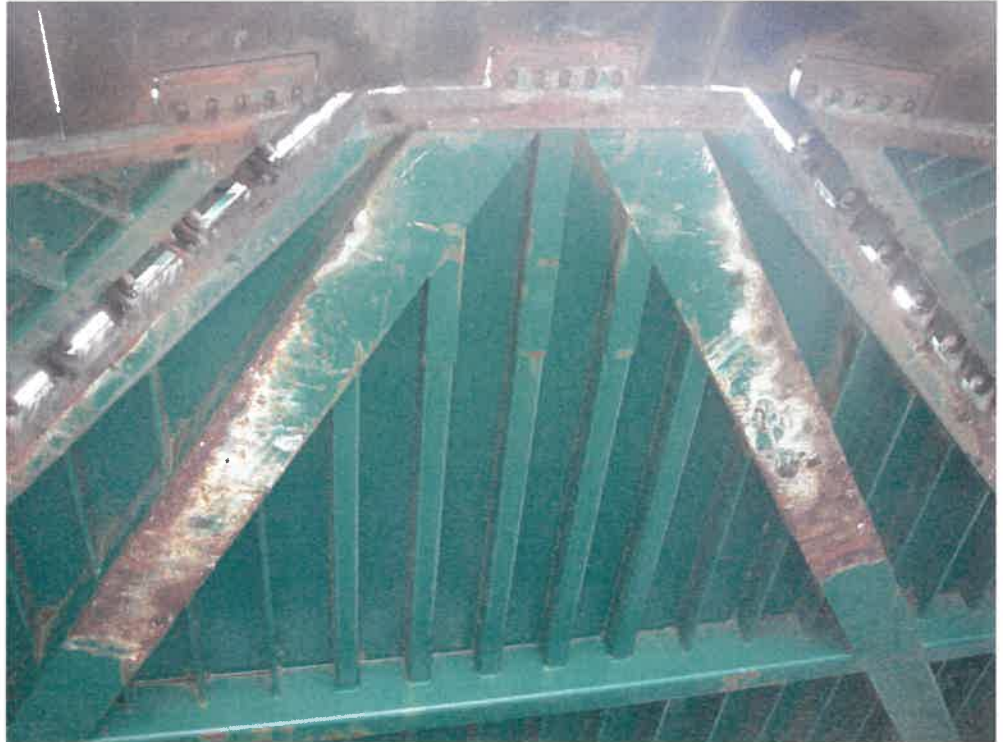
SI-118

The Apron has four stainless steel hinge pins. Support plates have section loss due to laminar rust, with section reduced to 7/16" from 3/4" at several plate edges (Photo #118) (2 placed in CS3). REPAIR #10018.

Apron pins have corrosion section loss to the hinge support plates.

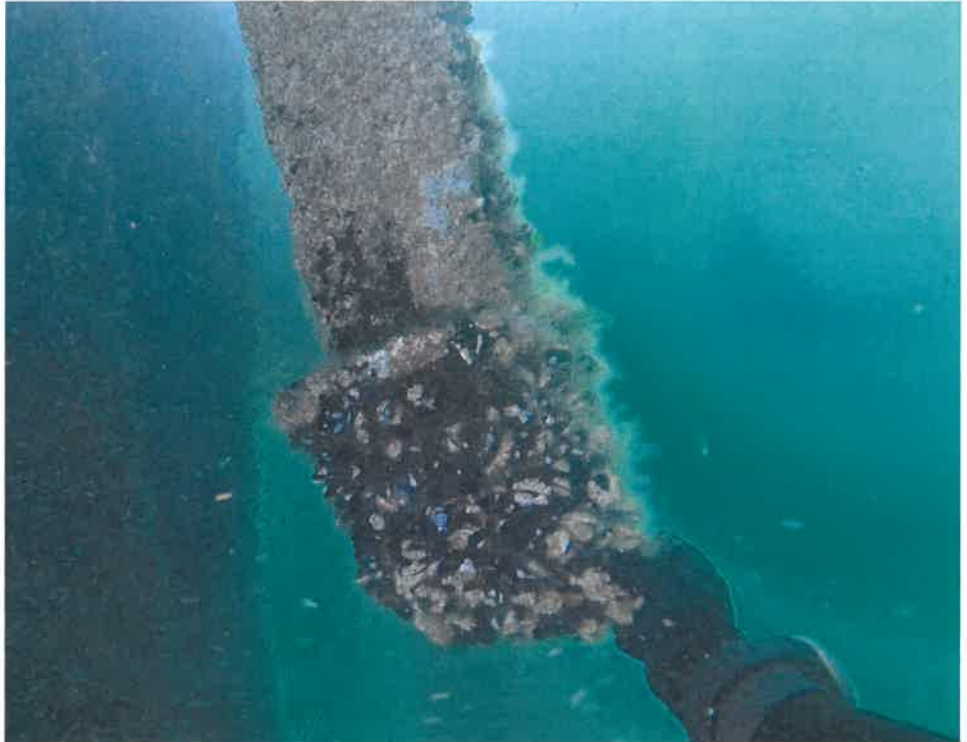
SI-106

The left steel tower midpoint horizontal member has a repaired seam crack (Photo #106)

Inboard end of repaired crack on horizontal member, left tower.

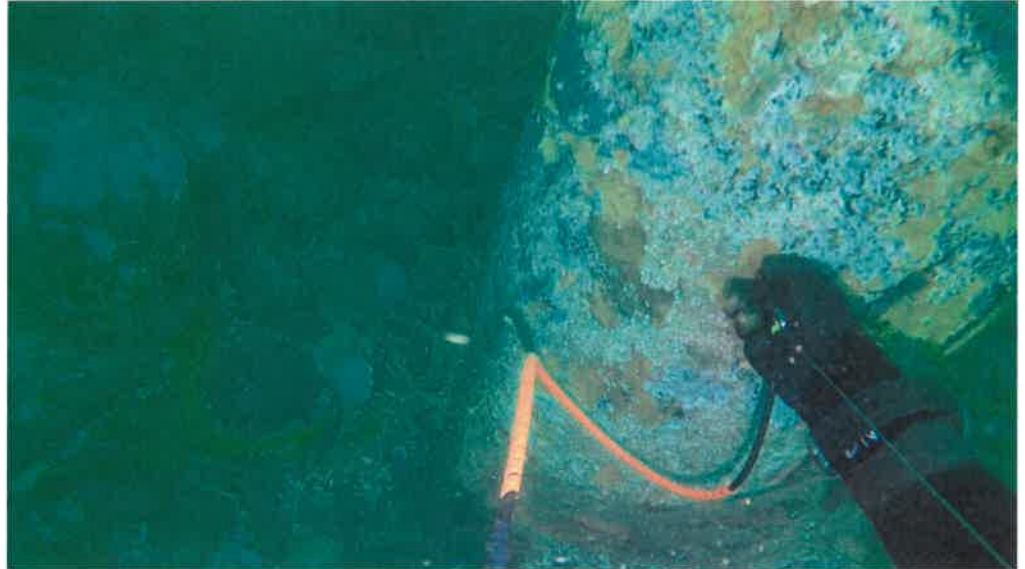
UW-9

Left wingwall fender piles typically have pitting with section loss up to 20% from MDL up to MDL + 13'. LW Pile 1C shown.

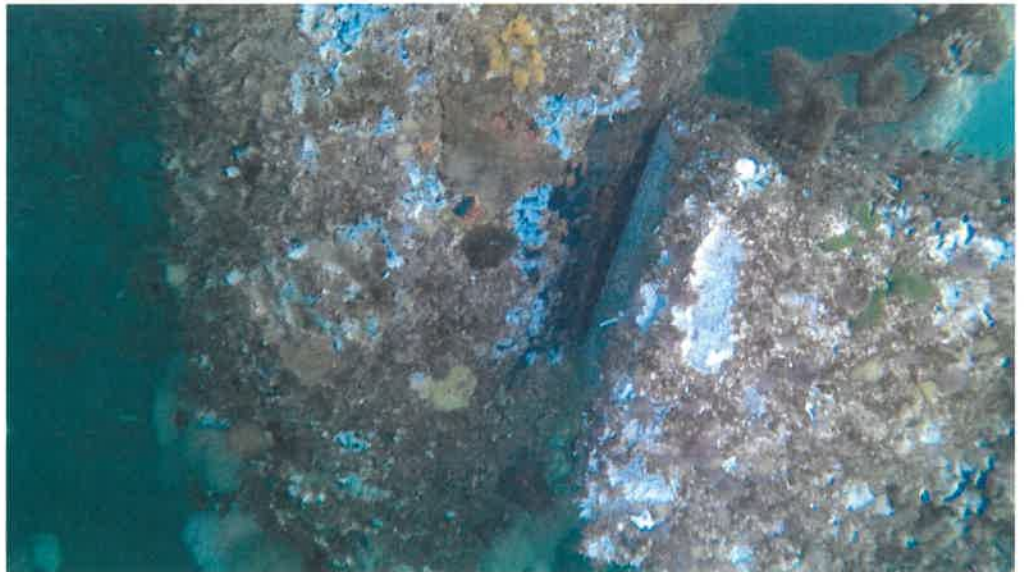
Floating Timber Dolphin has loose rubbing plastic sheathing on the inshore end. There are a couple abraded transverse bottom walers at the end (Photo #17).

Loose rubbing sheets on shore end of floating dolphin. Looking left and onshore.

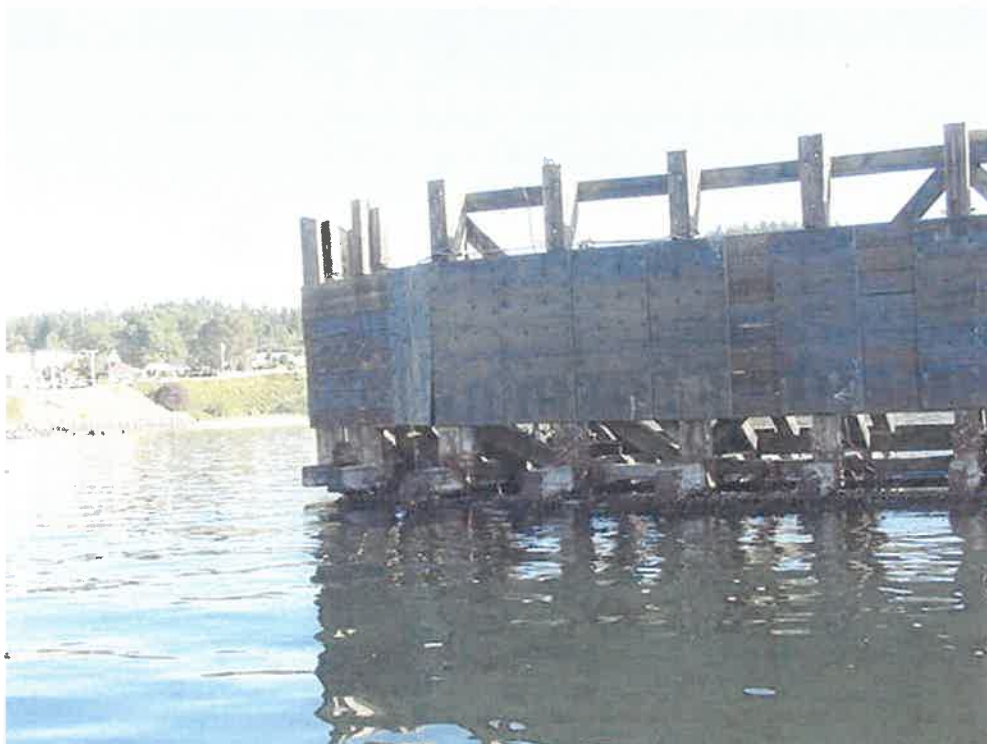
MI-69

Red and yellow tagged bracing in the Slip 1 floating dolphin.

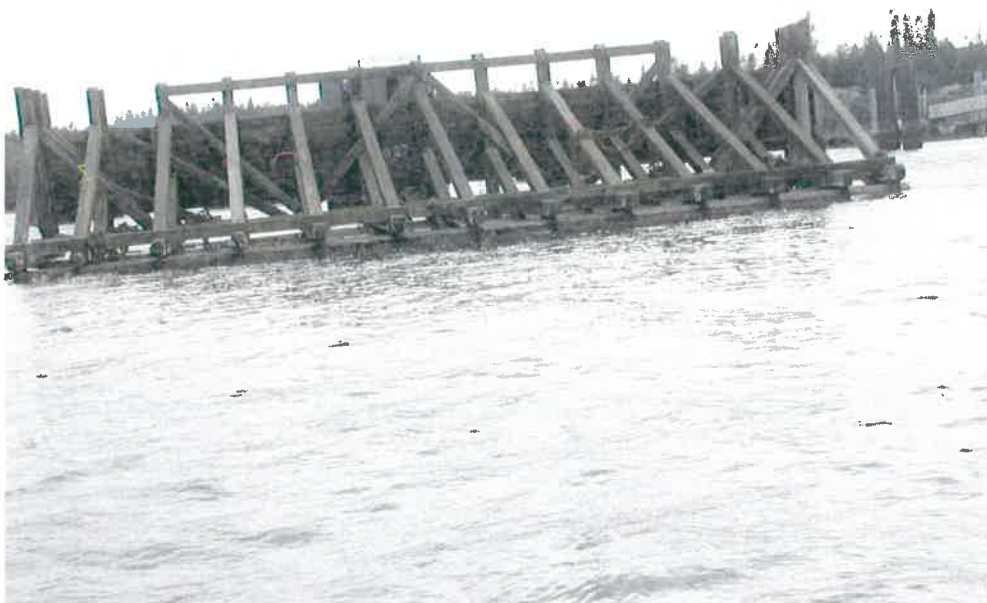
Pontoons, chains, and anchors were inspected. The timber dolphin is listing into the water offshore slipside where it's 1.5 ft. lower than the inshore left (Photo UW-14). Two of the slip side pontoons have large holes up to 3'(W) x 6' (L) with disintegrating flotation material visible inside (Photos UW-15 and UW-16). REPAIR #10020.

The timber dolphin is listing where it's 1.5 ft. lower than the inshore left.

REPAIR #10020 was created to repair or replace the timber floating dolphin steel pontoons.

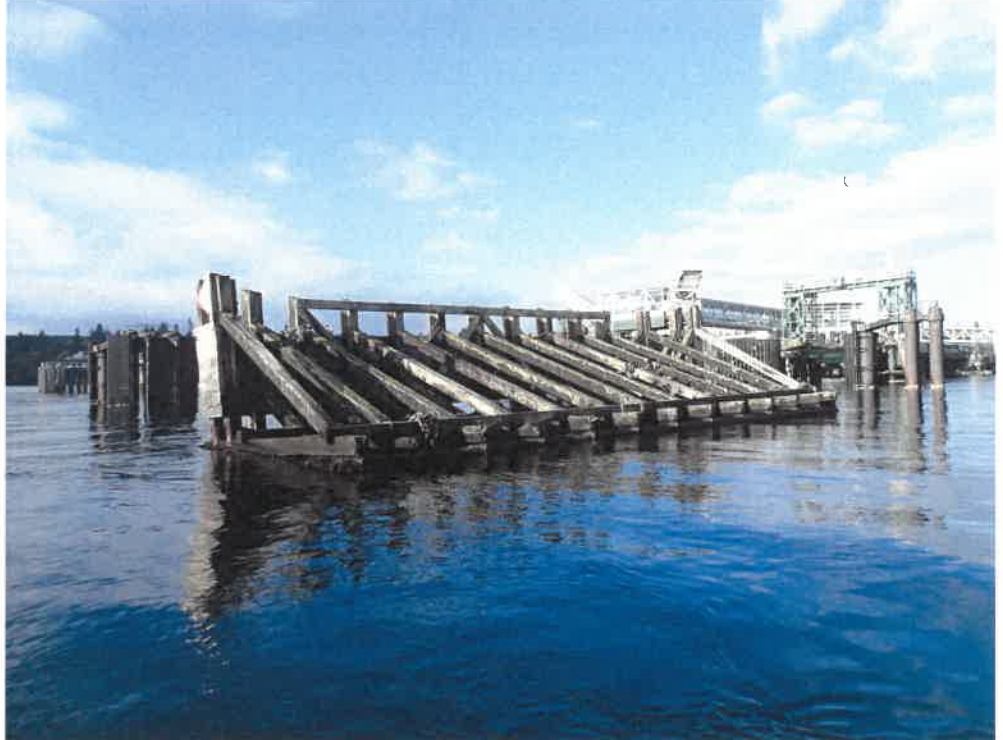
UW-15

Timber dolphin steel pontoon large hole 3'(W) x 6'(L).

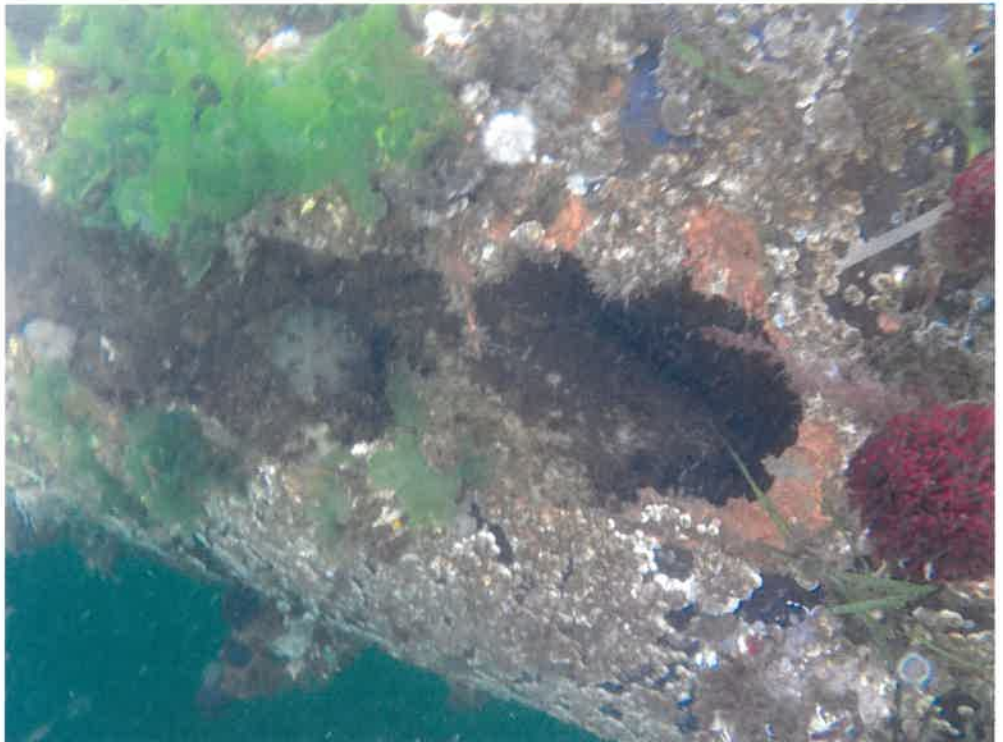
Inside of one of the timber dolphin steel pontoon holes.

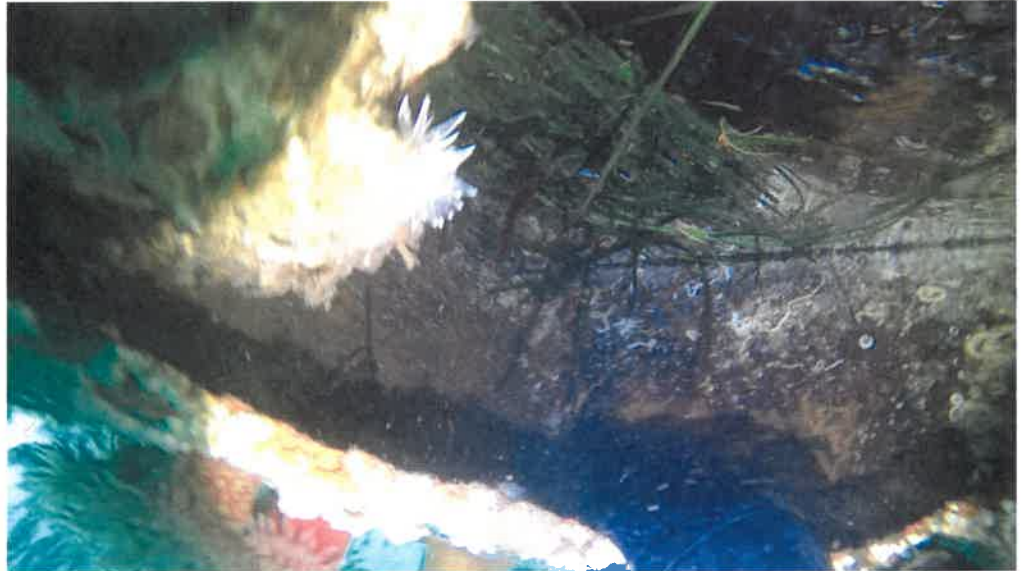
UW-17

Both back chains (B1 and B2) are in satisfactory condition with section loss up to 20% (Photo UW-17). Both back chains disappear into the sand and their anchors were not located. All three front (slip side) chains were found to have section loss just below the pontoon to where they hit the ground. Chain F1 had up to 20% overall section loss of chains (Photo UW-18), Chain F2 has up to 50% overall section loss, and Chain F3 has up to 75% of overall section loss and fretting (Photos UW-19 and UW-20). REPAIR #10021.

Both back chains have section loss up to 20%.

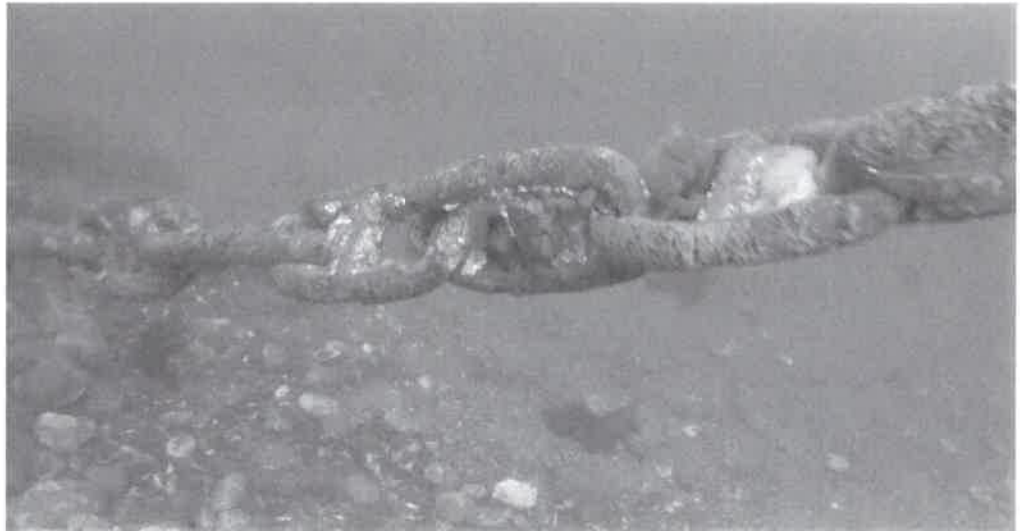
UW-19

Chain F3 has up to 75% of overall section loss and fretting in chain links directly below pontoon.

REPAIR #10021 was created to repair or replace the timber floating dolphin front anchor chains.

10021	1	B	Repair or replace timber floating dolphin Chains F2 and F3 which have links with 50% and 75% overall section loss near the dolphin.	8463	10/11/2017		
10022	2	B	Replace LI dolphin ladder sinker block rope attachment and evaluate the need for a sinker block on the LO dolphin ladder.	8910	10/11/2017

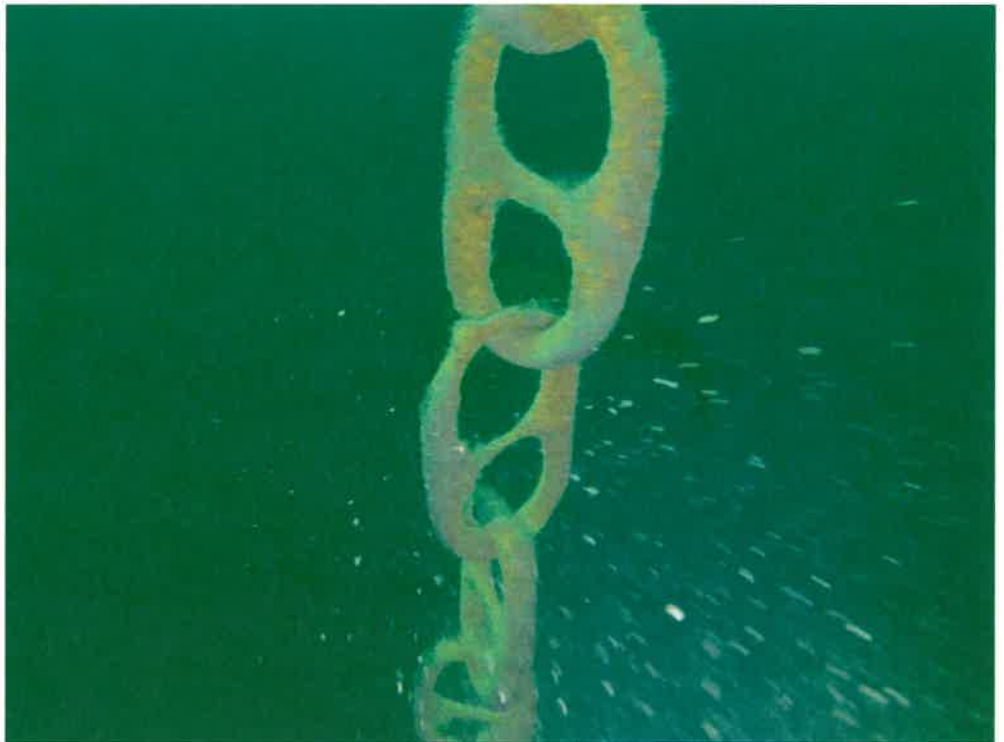
Chain F3 has up to 75% of overall section loss and fretting in links directly below pontoon

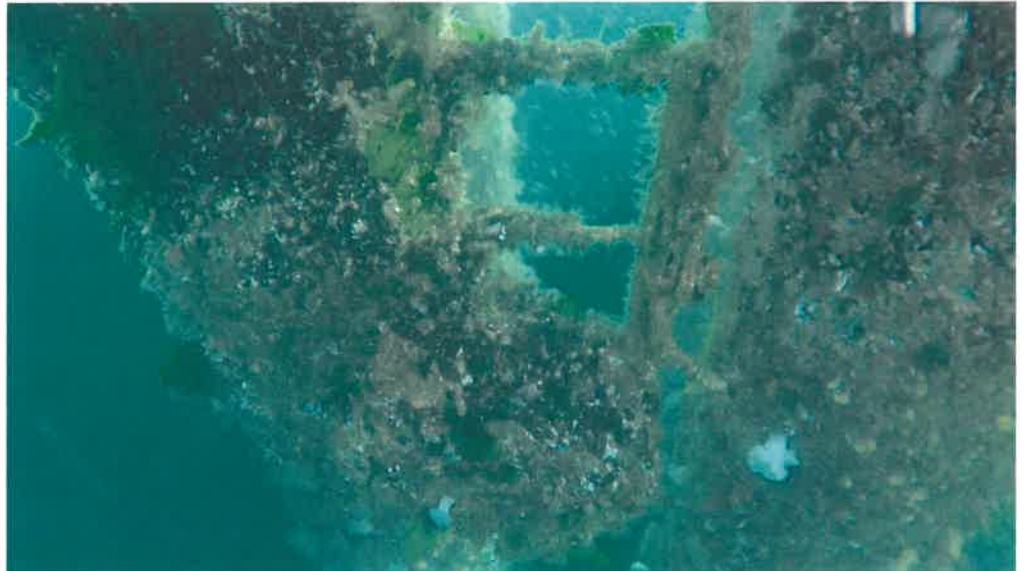
LI dolphin has ladder with sinker block tied on right side to rungs by a rope (Photo UW-22). The rope is deteriorating. The LO dolphin ladder does not have a sinker block and the ladder shows no attachments or holes for attachments (Photos UW-23 and UW-24). REPAIR #10022.

The LO dolphin ladder does not have a sinker block. Color has been reduced for picture clarity.

REPAIR #10022 was created to repair the left inner ladder sinker block attachment and to evaluate the need for a left outer dolphin ladder sinker block.
